February 19, 2013

RE: MAHONING COUNTY
MAHONING VALLEY RACE COURSE
NPDES PERMIT NO. OHC000003
OHIO EPA PERMIT NO. 3GC05333*AG
CONSTRUCTION STORM WATER INSPECTION

NOTICE OF VIOLATION

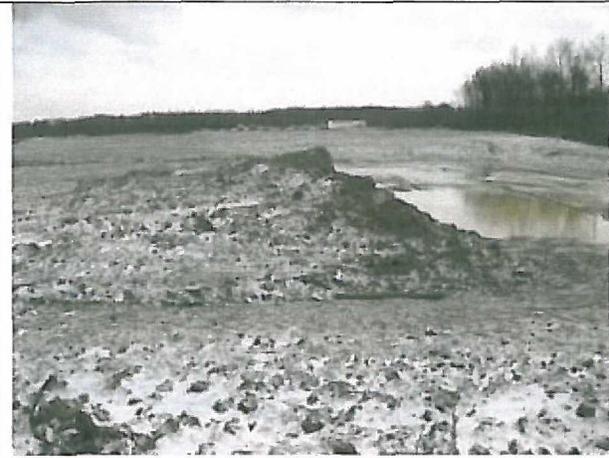
- Grading activities have commenced on the site and the sediment basins have not been installed. Mr. Van Dusen stated that construction activities commenced December 21, 2012. "Permanent sediment basin B" was partially constructed and was not functional (Figure 1). Part III.G.2.d.i of the General Storm Water Permit requires "sediment control structures shall be functional throughout the course of earth disturbing activity. Sediment basins and perimeter sediment barriers shall be implemented prior to grading and within seven days from the start of grubbing." **The failure to have implemented sediment basins prior to grading constitutes violations of Ohio Revised Code Chapter (ORC) 6111.07 and Part III.G.2.d.i of the General Storm Water Permit.**

Figure 1 - "Permanent sediment basin B" was partially constructed and was not functional.

- The SWP3 must be immediately implemented at the site, which includes the construction of all sediment basins and associated sediment basin control structures (i.e. dewatering skimmer).
- A copy of the site's revised SWP3 that addresses all of the above SWP3 deficiencies;
- Copies of all the inspection reports for the period consisting of December 21, 2012 to February 19, 2013; and
- A report detailing the corrective action(s) that will be or have been implemented to address the violations, detailed above. The report must include dates when each corrective action has been or will be implemented and completed.

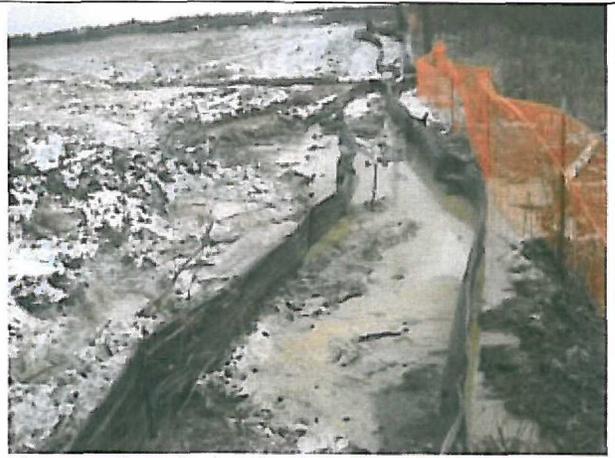
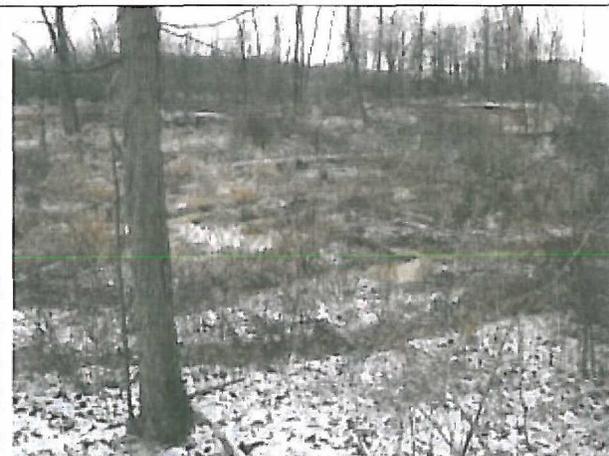
- Untreated sediment-laden storm water runoff was discharging from the uncompleted "permanent sediment basin B" and directly into a protected wetland and stream complex that has been labeled "do not disturb" on the storm water pollution prevention plan (SWP3) (Figures 2 to 3). **The discharge of pollutants to "waters of the State" constitutes violations of ORC 6111.07, Ohio Administrative Code Chapter (OAC) 3745-1-04(A), OAC 3745-1-04(C), and Part III.G.2.d of the General Storm Water Permit.**

Figure 2 - Untreated sediment-laden storm water runoff was discharging directly into a wetland and stream complex.

Figure 3 - Untreated sediment-laden storm water runoff was discharging directly into a wetland and stream complex.

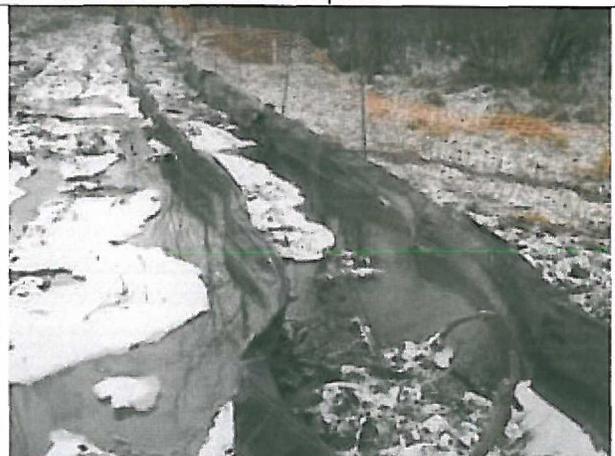
- Concentrated storm water runoff was directed to silt fence that was failing in the area where "temporary sediment basin C" is to be located (Figure 4). Part III.G.2.d.ii of the General Storm Water Permit requires concentrated storm water runoff to be treated by a

sediment settling pond. **The failure to properly treat concentrated storm water runoff constitutes violations of ORC 6111.07 and Part III.G.2.d.ii of the General Storm Water Permit.**

Figure 4 - Concentrated storm water runoff was directed to silt fence that was failing.

- Additional sediment control best management practices (i.e. sediment settling ponds and diversion channels, etc.) must be implemented to replace the failing silt fence and straw wattles that have been installed within concentrated storm water discharges;

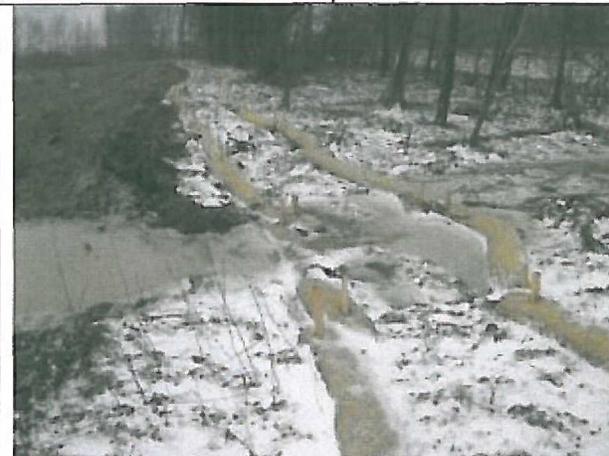
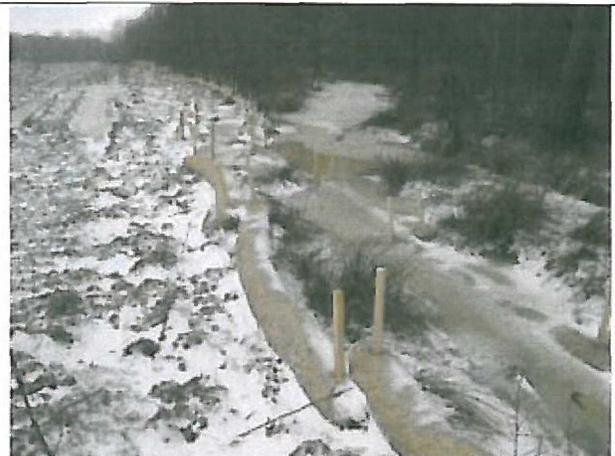
- Concentrated storm water runoff was directed to straw wattles that were failing in the areas where "temporary sediment basin E" and the outfalls from "permanent sediment basin A" and "temporary sediment basin E" are to be located (Figures 5 to 6). Straw wattles were also failing in the location located northwest of "permanent sediment basin A." Part III.G.2.d.ii of the General Storm Water Permit requires concentrated storm water runoff to be treated by a sediment settling pond. **The failure to properly treat concentrated storm water runoff constitutes violations of ORC 6111.07 and Part III.G.2.d.ii of the General Storm Water Permit.**

Figure 5 - Concentrated storm water runoff was directed to straw waddles that were failing.

Figure 6 - Concentrated storm water runoff was directed to straw waddles that were failing.

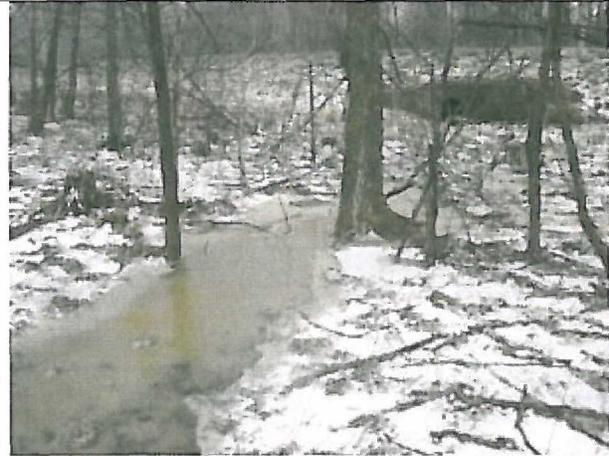
- Untreated sediment-laden storm water runoff was discharging from the area where silt fence and straw wattles were failing, as detailed above (Figure 7). **The discharge of pollutants to "waters of the State" constitute violations of ORC 6111.07, OAC 3745-1-04(A), OAC 3745-1-04(C), and Part III.G.2.d of the General Storm Water Permit.**

Figure 7 - Untreated sediment-laden storm water runoff was discharging from the area where straw waddles were failing.

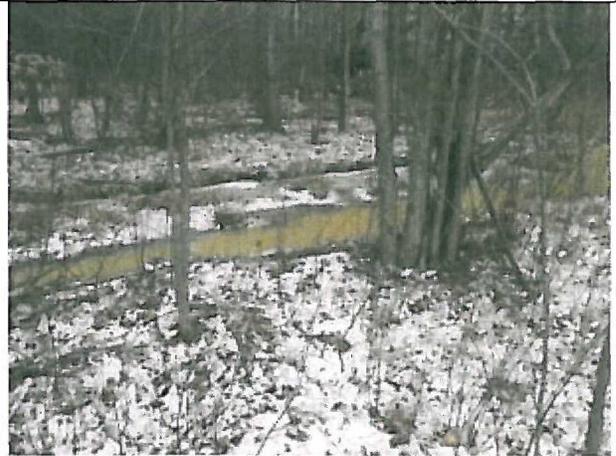
Figure 8 - Untreated sediment-laden storm water runoff was discharging from the area where straw waddles were failing.
