RE: TRUMBULL COUNTY
GREENE TOWNSHIP
GREENE CHURCH OF THE NAZARENE
NPDES GENERAL PERMIT NO. OHS000003
OHIO EPA PERMIT NO. 3GS00023

Ohio EPA performed a compliance evaluation inspection of the wastewater treatment works serving the above-referenced facility on March 28, 2013. The inspection was conducted to evaluate the overall operation and maintenance of the treatment works, and determine the facility's compliance with the terms and conditions of the National Pollutant Discharge Elimination System (NPDES) permit.

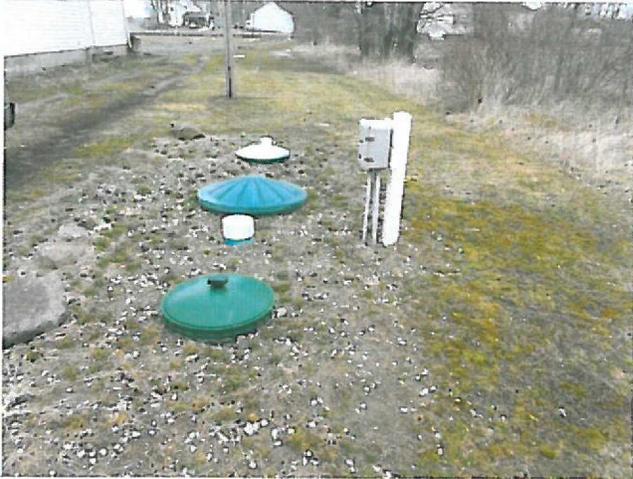
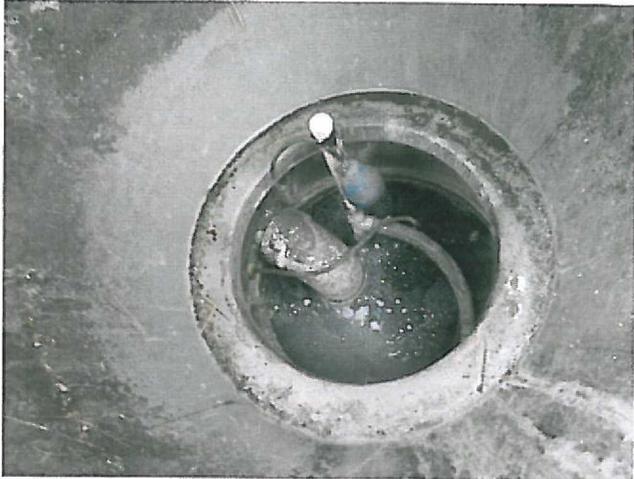
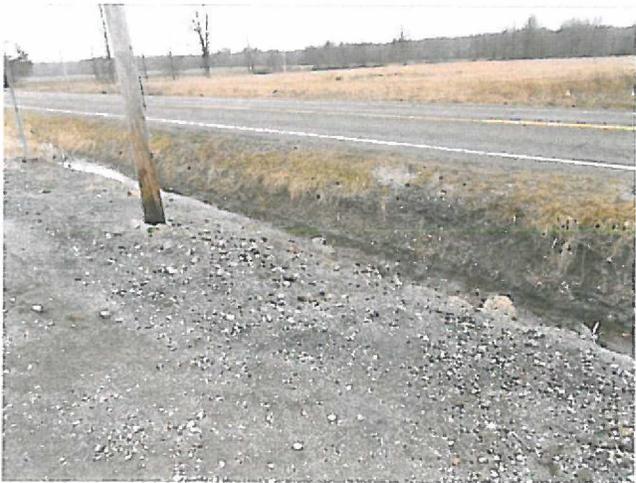
Attachments: Photographs

The existing treatment system is a prefabricated, aerobic treatment system, and consists of a 490-gallon trash trap, a 750-gpd aerobic treatment unit, a 525-gallon dosing/equalization tank, and a UV disinfection unit. Treated effluent is discharged to a nearby roadside ditch that is tributary to Mosquito Creek.

1. The overall operation and maintenance of the treatment works appeared to be marginal.
2. A bound and numbered logbook was not observed at the facility. Please ensure that a bound and numbered logbook is maintained on site, and used to document all operation and maintenance activities at the treatment plant. Plant operation and maintenance personnel should log their time in and out, the date, a brief description of the work performed, and their initials.

3. The wastewater in the treatment systems appears to be black in color – indicative of possible septic conditions.
4. The aerator did not appear to be functional. Please have it evaluated for functionality, and repaired immediately if necessary.

5. The high level indicator did not appear to be functional. Please have it evaluated for functionality, and repaired immediately if necessary.
6. Part IV, I of the facility's NPDES permit requires that an outfall sign be erected no later than four months from the effective date of this permit, which was April 1, 2010. During

Please submit to Ohio EPA, within 14 days' receipt of this notification, written documentation describing the course of action that will be taken, or has been taken, to address the deficiencies identified in this letter. Your response shall include specific dates for the initiation and completion of this action plan.
