**RE: NPDES Reconnaissance Inspection and
Notice of Violation**

Mr. Todd Dugan
V.E. Beard Oil Co. Inc.
6990 Lima Street
Huntsville, OH 43324

NPDES COMPLIANCE INSPECTION REPORT

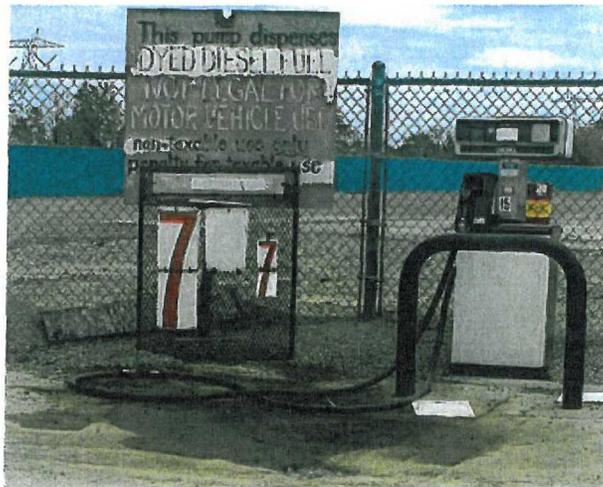
There were no issues associated with the storm drains serving the retail fuel islands but there was a significant amount of fuel on the ground around the tax-exempt diesel pump as shown the following picture:

Ms. Stevens recently informed me that a vehicle apparently ran over the hose, causing a rock to puncture it. She said the hose has since been replaced. I believe it is necessary to provide a better means of storing the long hose to minimize the chance of it being damaged.

- **There are two heating oil tanks (250-gallon metal tanks as used at residential homes)**
- **The tax-exempt diesel pump is exposed and there was a substantial amount of residual fuel on the ground around the pump and into the drain that used to serve the load rack.**

This area of your facility's operations should otherwise be evaluated to ensure possible tank overfills are avoided or are quickly cleaned up using absorbent material. Please evaluate your SWP3 as it pertains to this unsheltered fueling station and let me know of any plans for making improvements.
