RE: Nottingham Subdivision; NPDES Permit # 1GC04342*AG; Compliance Inspection Findings and Notice of Violation

Ohio EPA DSW Storm Water Section, Construction Site Visit Information Form

Site Name: Nottingham Land Development - Subdivision

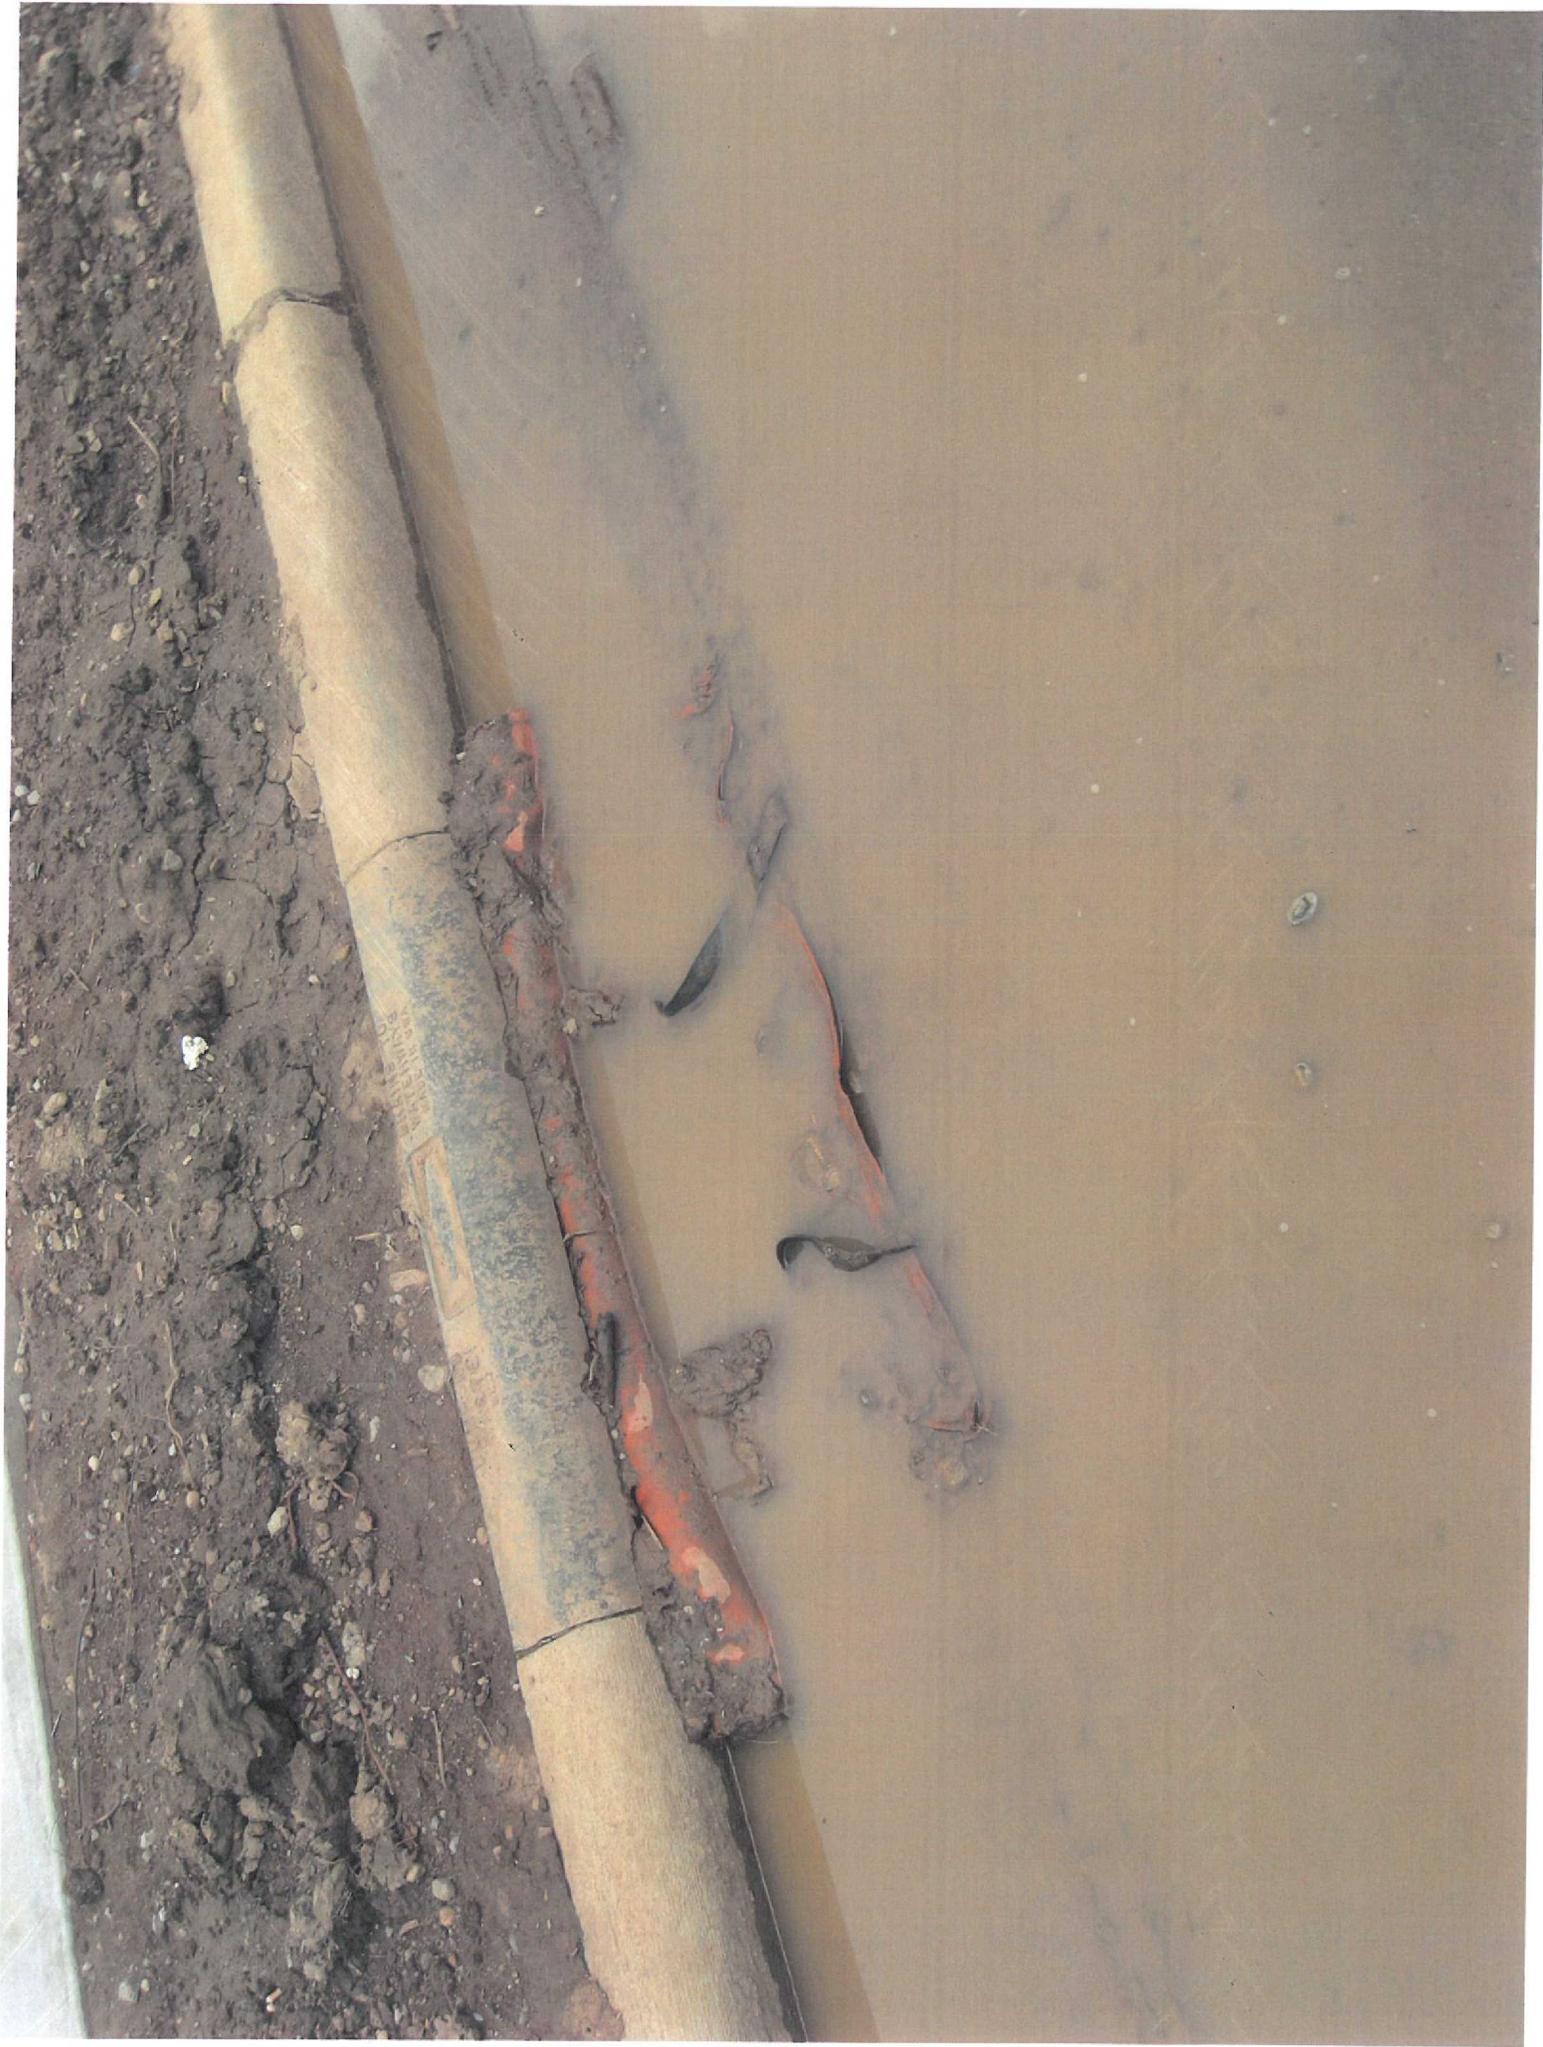
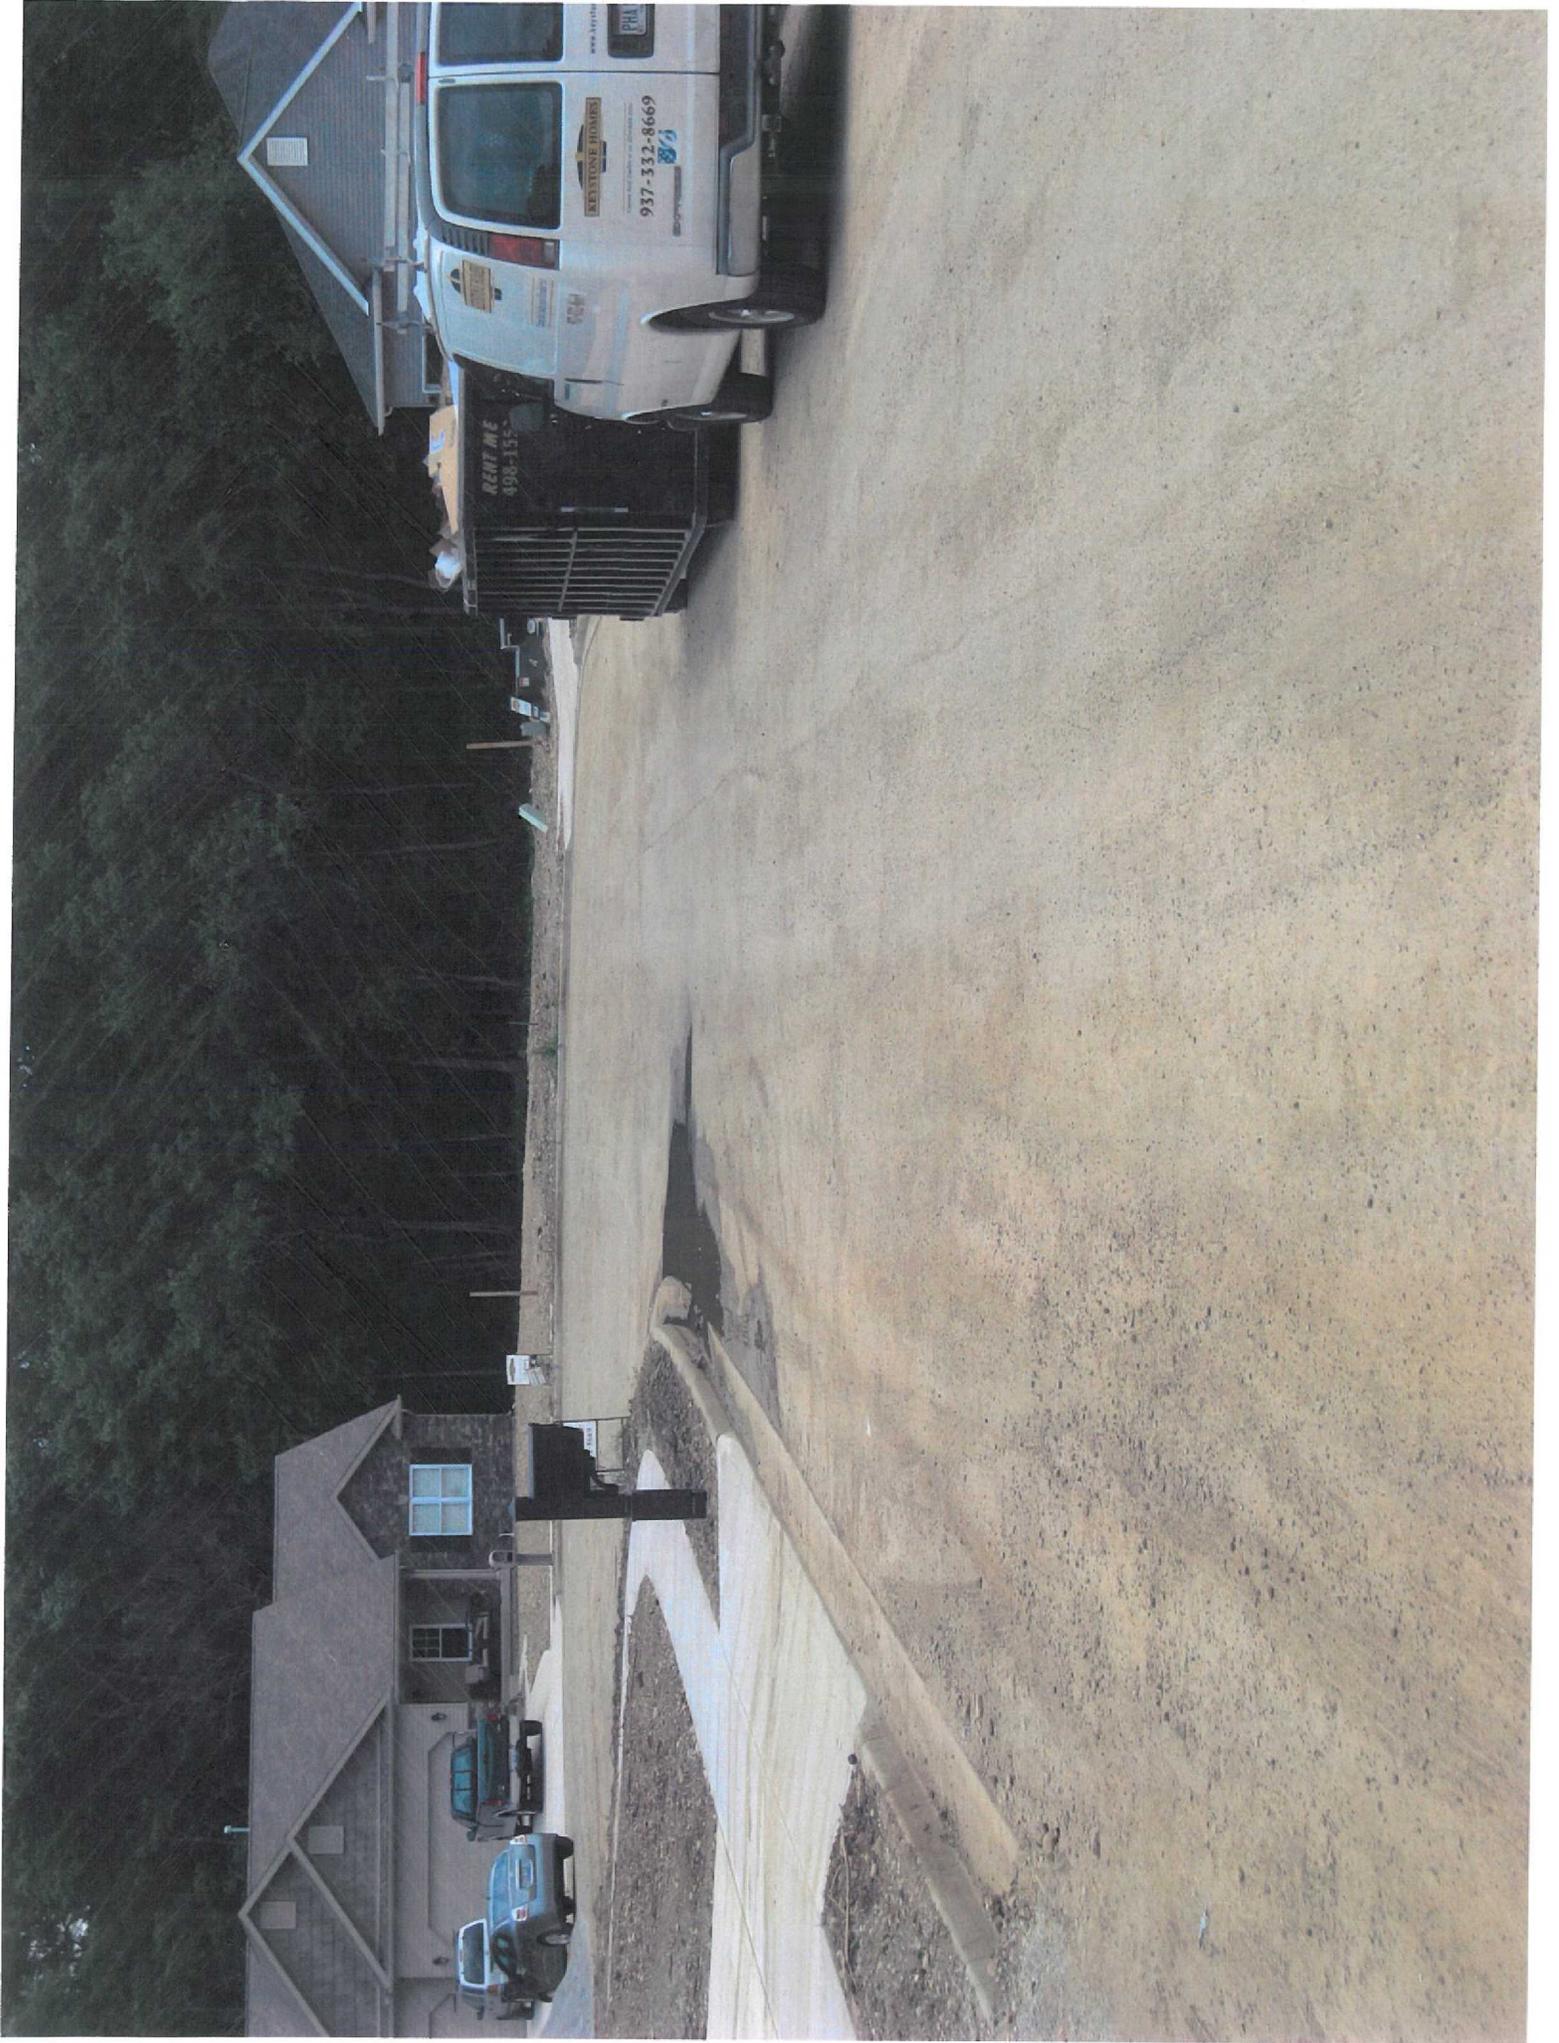
Proper maintenance of the inlet protection shall be conducted as needed. During my inspection, I observed that the dandy bags were covered in dirt/sediment which makes it difficult for water to drain into the storm sewer system. Large deposits of sediment are noticeable on the street which indicates that rainwater is washing sediment from the individual lots onto the street. Photographs are included to document this violation.

Explain: Proper Maintenance has not been fulfilled on Inlet Protection/Handy Bags
Flowing on street/sediment on Road

- Subdivision Permit - Does the coverage get turned over into
- ASK FOR SWP3 the Individual Lot owners
- STREET Covered in Dirt (Large Dirt Pile in the (ul-de-sac)

Stabilizing the barren soil at each individual lot within seven days of the latest disturbance will prevent any sediment from leaving the individual lots. If soil disturbance is to continue, I would suggest installing filter socks near the street, at each individual lot, until everything is permanently stabilized.

Explain, in your written response to this letter, what measures will be taken to maintain the inlet protection devices. Also, has the NPDES general construction permit coverage been handed over to the individual lot owners? Please explain in your written response to this office within 14 days of receipt of this letter.
