RE: St. George Russian Orthodox Church; NPDES Permit # 1GC04246*AG; Construction Site Inspection

Ohio EPA DSW Storm Water Section, Construction Site Visit Information Form

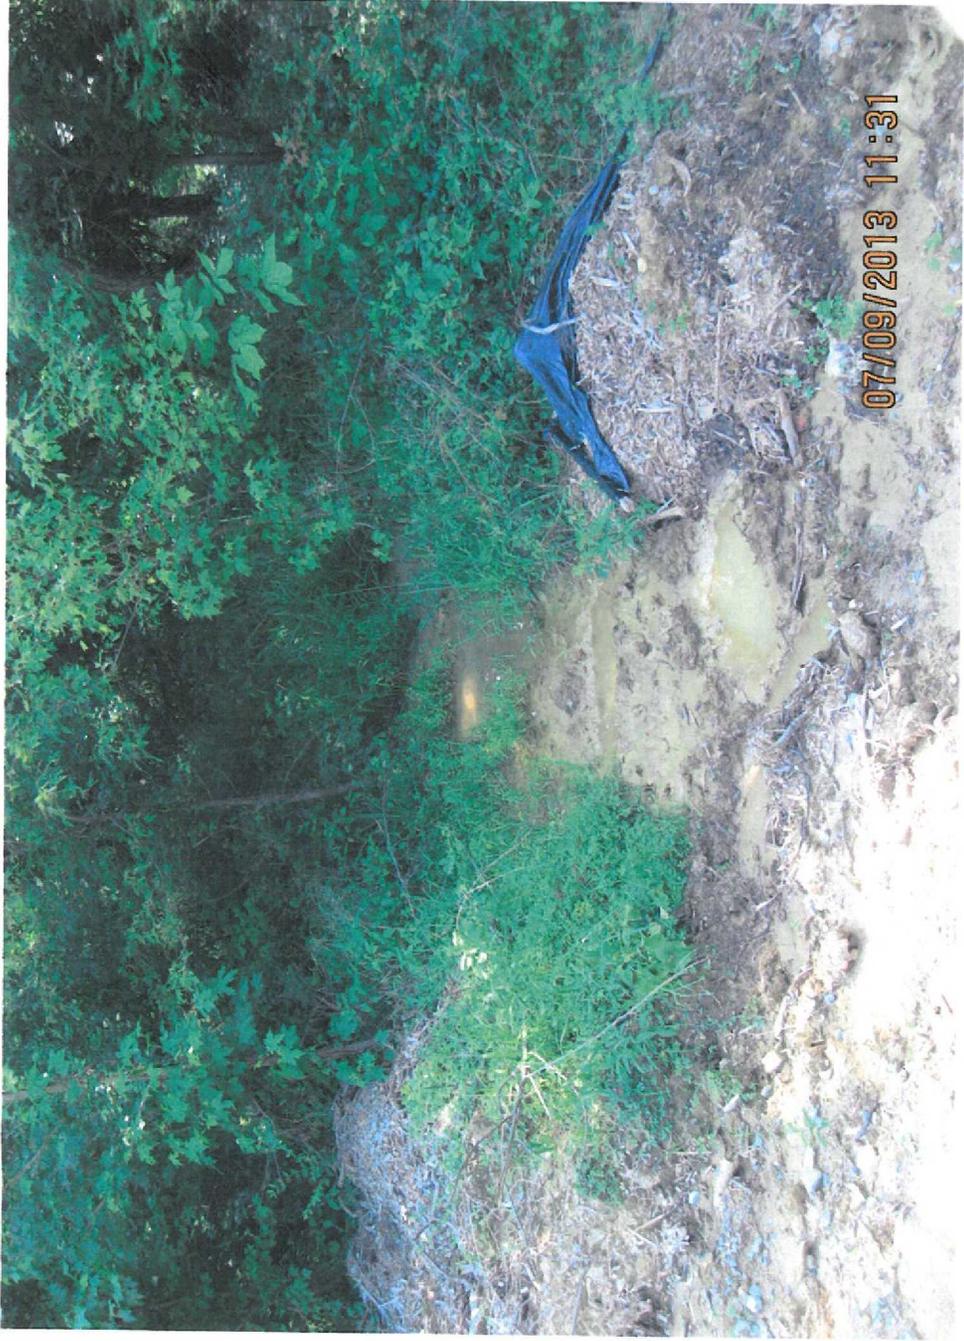
07/09/2013 11:31

I did notice that at the rear of the site there was an area where the mulch berm has failed and turbid water is leaving the site (see attached photo). However, because it is indicated in the approved permit that the receiving Municipal Separate Storm Sewer System (MS4) is the city of Loveland, I have reason to believe that the failure in this area may not be an issue. To confirm or deny this conclusion I ask that you please **send a copy of the sites SWPPP to the Ohio EPA Southwest District Office via mail or email for review by July 26, 2013.**

- no one in job trailer call work being done inside building
- mulch berm failure in back of site, failure an issue?
