**RE: CUYAHOGA COUNTY
CITY OF BEACHWOOD
CONSTRUCTION STORM WATER
PERMIT NO: 3GC06009*AG
COMMERCE PARK I, II, AND III**

NOTICE OF VIOLATION

On Monday July 8, 2013, I conducted an inspection at the above mentioned site to determine compliance with the Ohio EPA General Storm Water National Pollutant Discharge Elimination System (NPDES) Permit for Construction Activities #3GC06009*AG. Accompanying me on my inspection was Randy Allar, an inspector with GDP Group. We were able to meet with Bob Cockrell with NRP Group on site to review the SWP3 (Storm Water Pollution Prevention Plan). Our records indicate that Commerce Park Place Holdings LLC was granted coverage to discharge storm water under the general NPDES permit for construction activities on August 16, 2012.

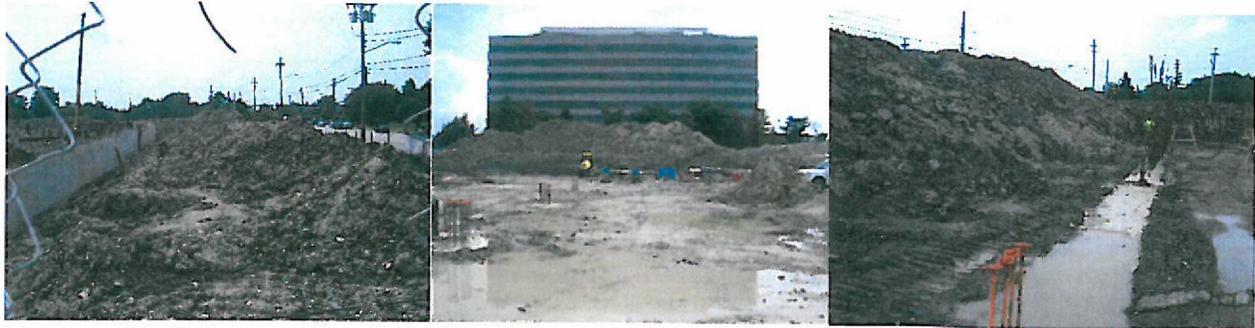
Figures 1,2 & 3: Temporary stabilization must occur on any disturbed area that will remain idle for 14 or more days.

- **Stabilization, i.e., seeding and mulching, has not been initiated as required by the NPDES permit.** Temporary stabilization must be initiated within seven days of last disturbance on any disturbed area of the site which shall remain idle for 14 or more days. Permanent stabilization must be initiated within seven days of reaching final grade. **The soil stockpiles surrounding the site all require stabilization should they remain undisturbed for 14 or more days. (Figures 1,2 & 3)**

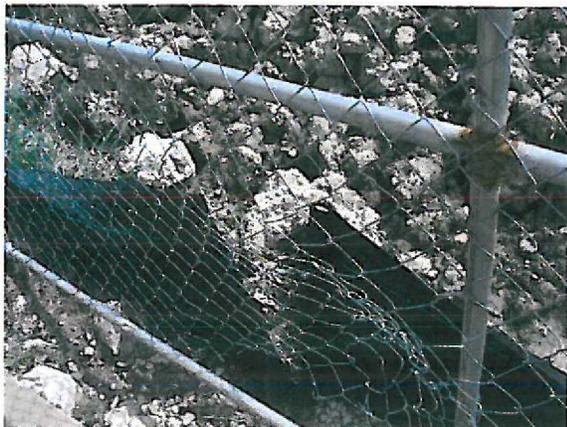
Figure 4: Silt fence not properly tied off at the ends. fails to prevent sediment from tracking off site.

- **Silt fence has not been installed in a functional manner or has not been maintained as required by the NPDES Permit. (Figure 4)** All sediment controls, including silt fence, must be capable of ponding runoff in order to settle sediment. The Silt fence must be trenched and backfilled and the joint stakes of the silt fence must be connected by twisting the stakes together prior to staking them into the ground. **Please ensure that all joints are twisted together and repair the silt fence so that it is functional.** The Silt fence must remain in place until the upslope contributing drainage area has reached final stabilization, i.e., a vegetative growth density of 70% or greater has been achieved.

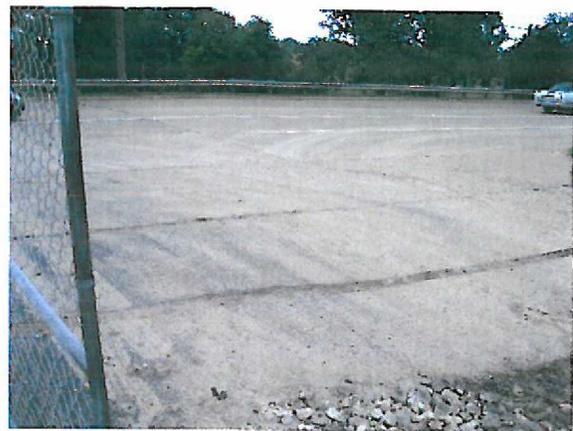
Figure 5: Rock construction entrance

- **The Rock Construction Entrance closer to Chagrin Blvd. (not the one with the wheel washing station) was inadequate, resulting in sediment tracking off site. (Figure 5)** Specifications for a Rock Construction Entrance can be found in Chapter 7 of the *Rainwater and Land Development Manual, Ohio's Standards for Stormwater Management, Land Development and Urban Stream Protection* (Ohio Department of Natural Resources, 2006).

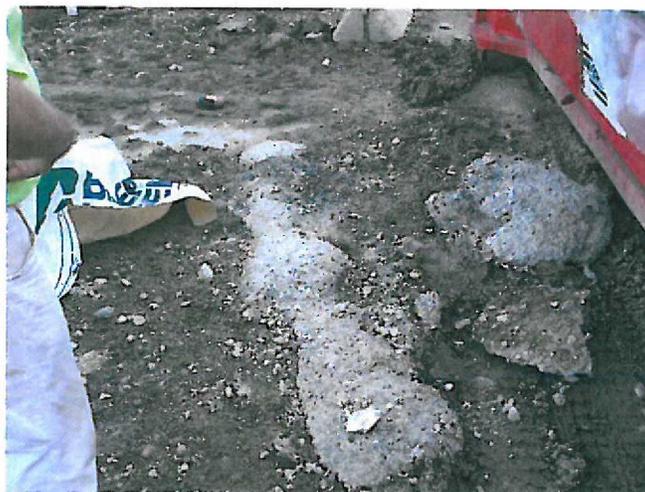
Figure 6: Not all concrete is being washed out in the concrete washout dumpster.

- **Non-sediment pollution controls require repair and maintenance as per the NPDES Permit.** Not all of the concrete washed out on site ended up in the concrete washout pit. **(Figure 6)** Ensure that all parties are aware that inside the concrete washout dumpster is the only place on site where concrete washout is permitted.
