July 30, 2013

RE: CUYAHOGA COUNTY
CITY OF WESTLAKE
CONSTRUCTION STORM WATER
PERMIT NO: 3GC06197*AG
WESTHAMPTON PHASE 3

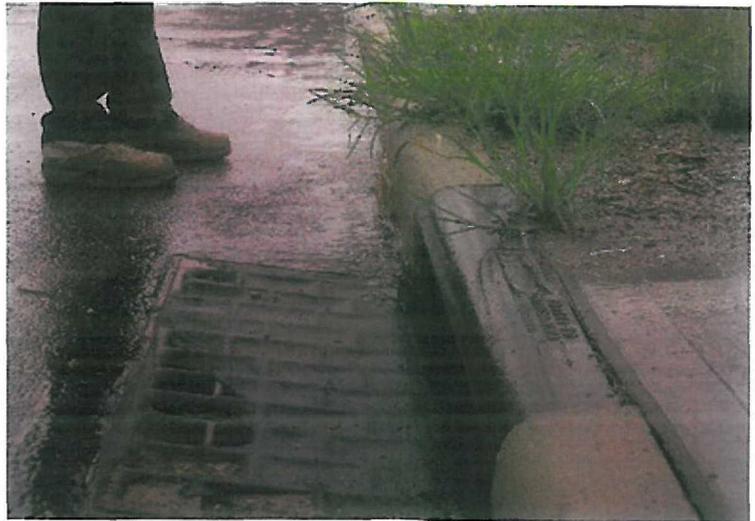
- **Storm drain inlet protection has not been constructed per specifications contained in the SWP3. (Figure 2)** Curb inlet protection is in need of repair and maintenance. Please review the specifications contained in the SWP3 and in *Rainwater and Land Development, Ohio's Standards for Stormwater Management, Land Development and Urban Stream Protection* (Ohio Department of Natural Resources, 2006), and install/repair inlet protection to meet these standards.

Figure 2: Curb inlet protection in need of repair.

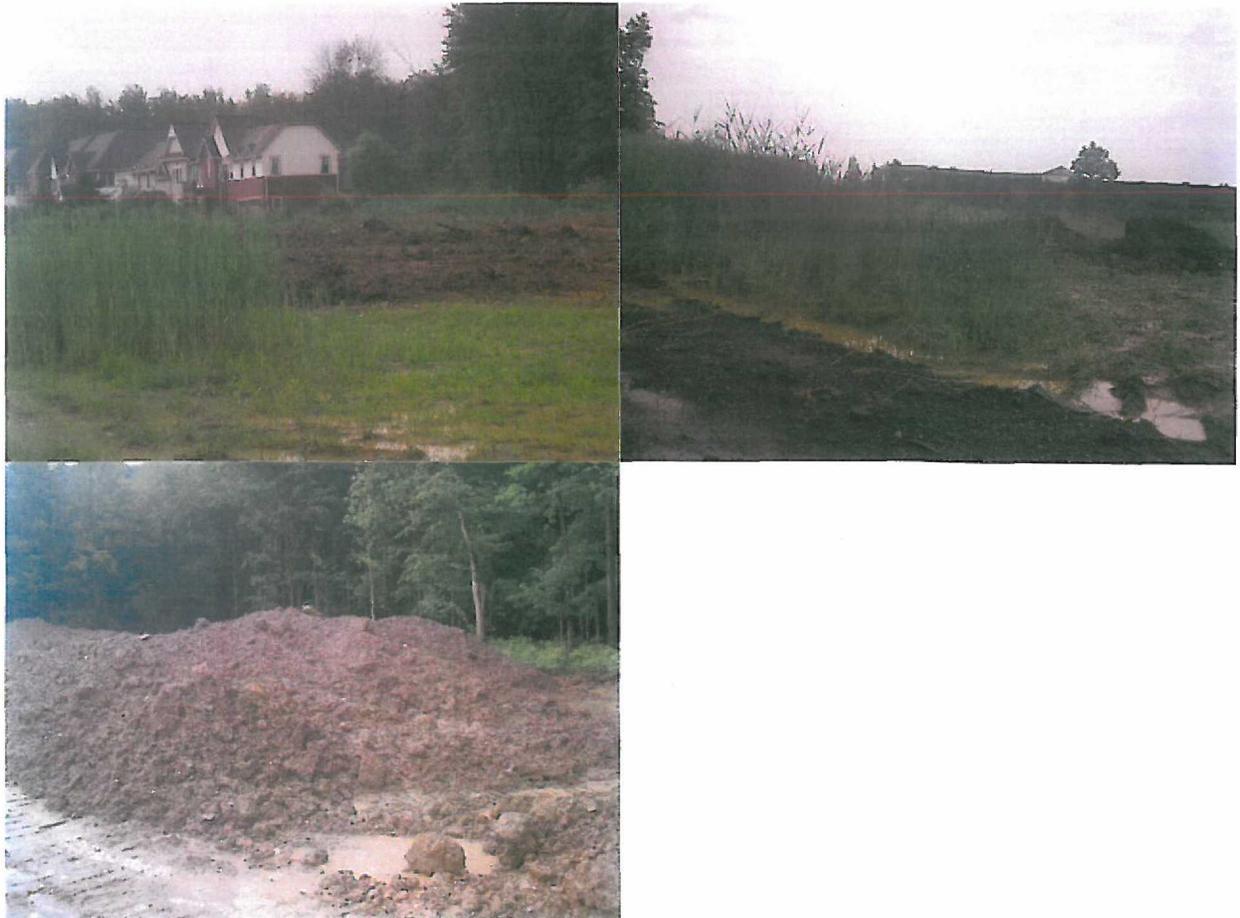
- **Stabilization, i.e., seeding and mulching, has not been initiated as required by the NPDES permit. (Figures 3, 4 & 5)** Temporary stabilization must be initiated within 7 days of last disturbance on any disturbed area of the site if it will not be further disturbed within 14 days of last disturbance. Permanent stabilization must be initiated within 7 days of reaching final grade. **No stabilization was present on the disturbed area to the west of Dick's or on the soil stockpiles on the southern site.**

Figures 3, 4 & 5: Stabilization is required where sediments will remain undisturbed for 14 or more days.
