RE: CUYAHOGA COUNTY
CITY OF WESTLAKE
CONSTRUCTION STORM WATER
PERMIT NO: 3GC06288*AG
GET GO #3316

NOTICE OF VIOLATION

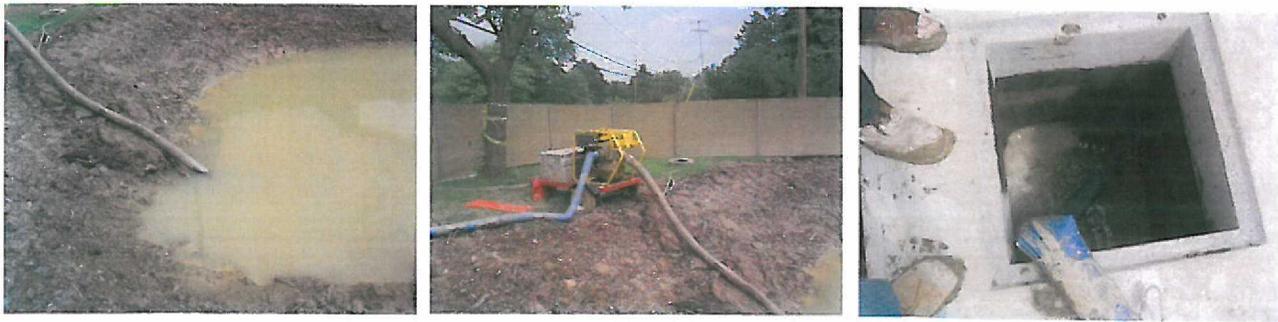
- While on site we observed water being pumped up from the sediment pond and into a catch basin. **(Figures 1, 2 & 3)** John told us that the water from the sediment basin was going into a city sanitary sewer, with the cities approval. We discussed this with Robert Kelly from the City of Westlake Engineering Department and he did not have any knowledge of this discharge and informed us that this catch basin in question is a city storm sewer. **Discharge from a sediment basin into a city storm sewer is an illicit discharge and violation of Part III.G.2.g.iv of the NPDES Permit. Per Section III.G.2.d of the NPDES Permit, sediment basins and perimeter sediment barriers shall be implemented prior to grading and within seven days from the start of grubbing.**

Figures 1, 2 & 3: Pumping water from a sediment basin into city storm sewers is an illicit discharge.

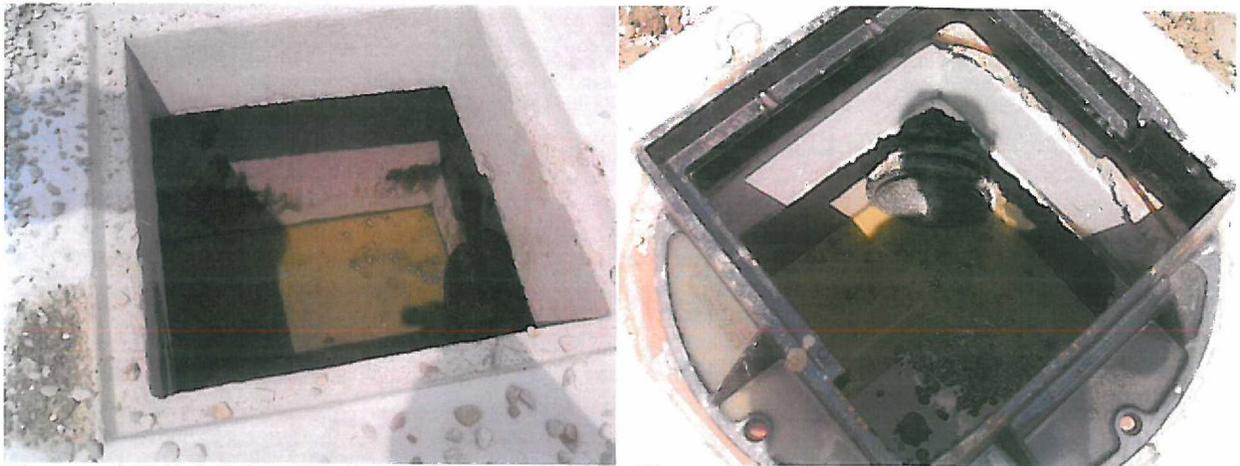
- **Storm drain inlet protection has not been constructed per specifications contained in the SWP3.** Several catch basins were missing inlet protection entirely. **(Figures 4 & 5)** Please review the specifications contained in the SWP3 and in *Rainwater and Land Development, Ohio's Standards for Stormwater Management, Land Development and Urban Stream Protection* (Ohio Department of Natural Resources, 2006), and install/repair inlet protection to meet these standards.

Figures 4 & 5: Inlet protection has been removed/is not in place, contrary to what was indicated on the SWP3.

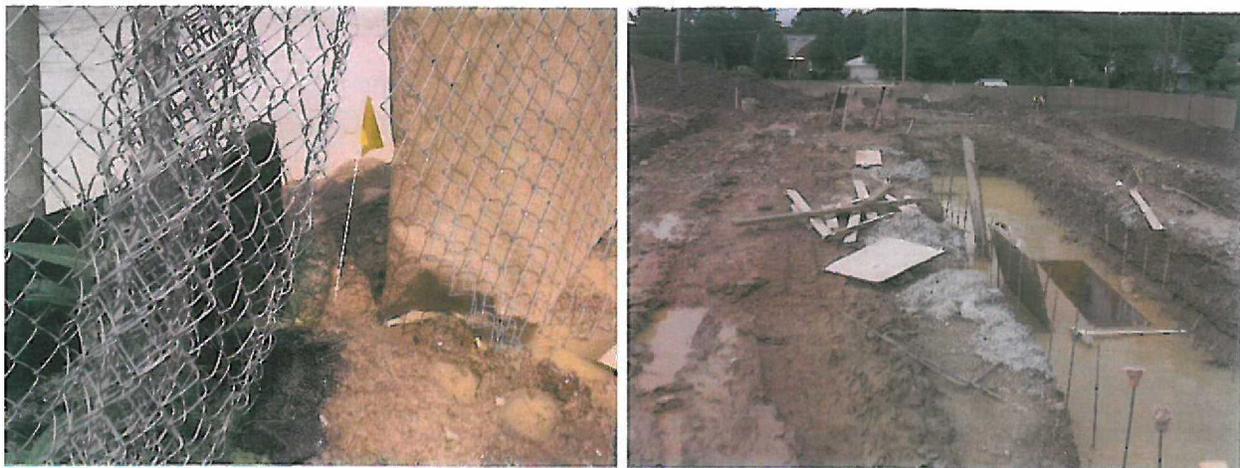
- **Silt fence has not been installed in a functional manner or has not been maintained as required by the NPDES Permit. (Figure 6)** All sediment controls, including silt fence, must be capable of ponding runoff in order to settle sediment. Silt fence must be trenched and backfilled and the joint stakes of the silt fence must be connected by twisting the stakes together prior to staking them into the ground. Silt fence must remain in place until the upslope contributing drainage area has reached final stabilization. (i.e., a vegetative growth density of 70% or greater has been achieved.)

Figure 6: Silt fence failing to contain sediment on site

Figure 7: Concrete/mortar washout is to occur only at a concrete washout pit.

- **Non-sediment pollution controls require repair and maintenance as per the NPDES Permit. ALL** concrete wash out is to occur **ONLY** at the washout pit location. **(Figure 7)** We observed a hole at the bottom of the dumpster that is being kept on site which, when full, will allow leachate to discharge onto the bare ground outside the dumpster. **(Figure 8)** Covering the dumpster with a tarp or lid at the end of the night will control the generation of leachate.

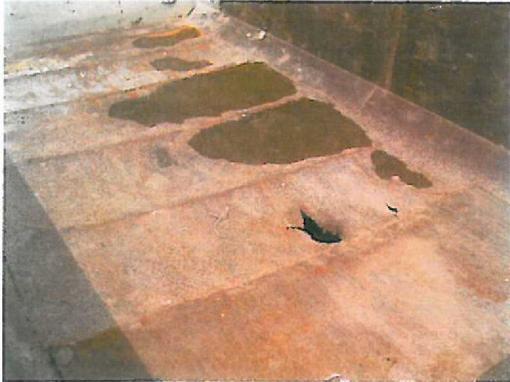
Figure 8: Trash leachate will leak through the hole if dumpster remains uncovered.
