RE: GEAUGA COUNTY
MIDDLEFIELD TOWNSHIP
INDUSTRIAL STORM WATER
MIDDLEFIELD METAL RECYCLING
3GR01846*AG
NOTICE OF VIOLATION

MIDDLEFIELD METAL RECYCLING
Middlefield Township Geauga County

Photos Taken: July 25, 2013
By: Juliana Murphy, DSW, NEDO

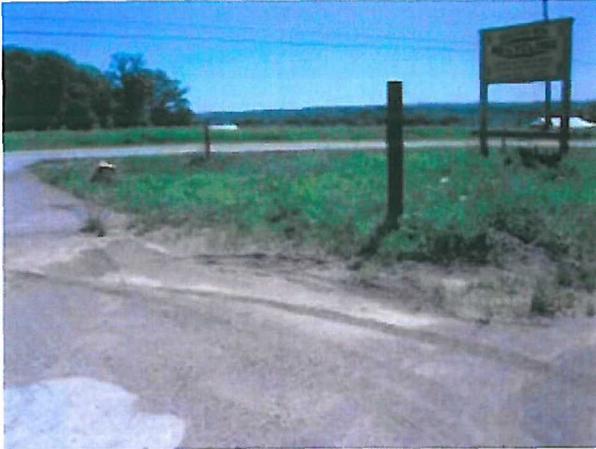
- During the inspection, Jane and I identified a new outfall on the south side of the entrance. There was a decent amount of sediment build up around this outfall. Best Management Practices (BMPs) along with good housekeeping should be implemented to decrease and eliminate the amount of sediment leaving the site. **(See Fig 1)**

Figure 1: (*top left*) Newly Identified Outfall on south end of entrance
Figure2: (*middle left*) Stock pile of tires
Figure 3: (*bottom left*) Stains on the ground under dumpster
Figure 4: (*top right*) Unkempt outfall (storm drain)
Figure 5: (*bottom right*) Stock pile of car parts

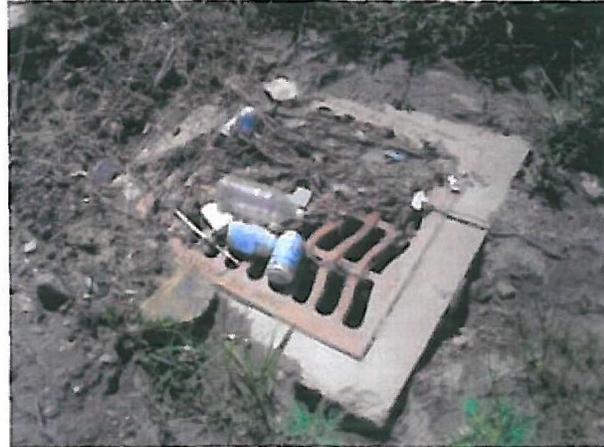
- Good housekeeping is needed at the storm drain outfall. Sediment build up along with trash was noted during the inspection. **(See Fig 4)**
- There was a stock pile of tires on the site. The tires should be stored in some sort of containment to prevent them from causing any sort of pollution. **(See Fig 2)**
