August 7, 2013

RE: LORAIN COUNTY  
CITY OF AVON  
CONSTRUCTION STORM WATER  
PERMIT NO: 3GC006359\*AG  
STONEBRIDGE ESTATES SUBDIVISION

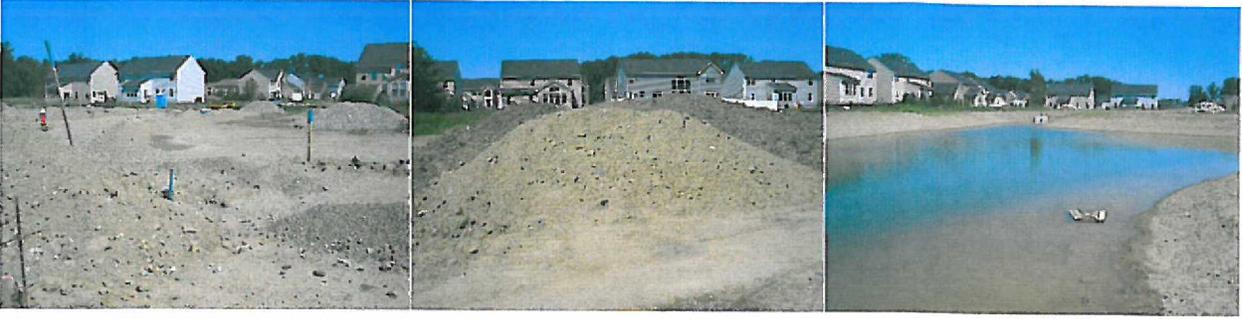
- **Stabilization, i.e., seeding and mulching, has not been initiated as required by the NPDES permit. (Figures 1,2&3)** Temporary stabilization must be initiated within 7 days of last disturbance on any disturbed area of the site if it will not be further disturbed within 14 days of last disturbance. Permanent stabilization must be initiated within 7 days of reaching final grade.

**Figure 1,2&3:** Soil stabilization is to occur on any undisturbed areas that will remain unworked for 14 or more days.

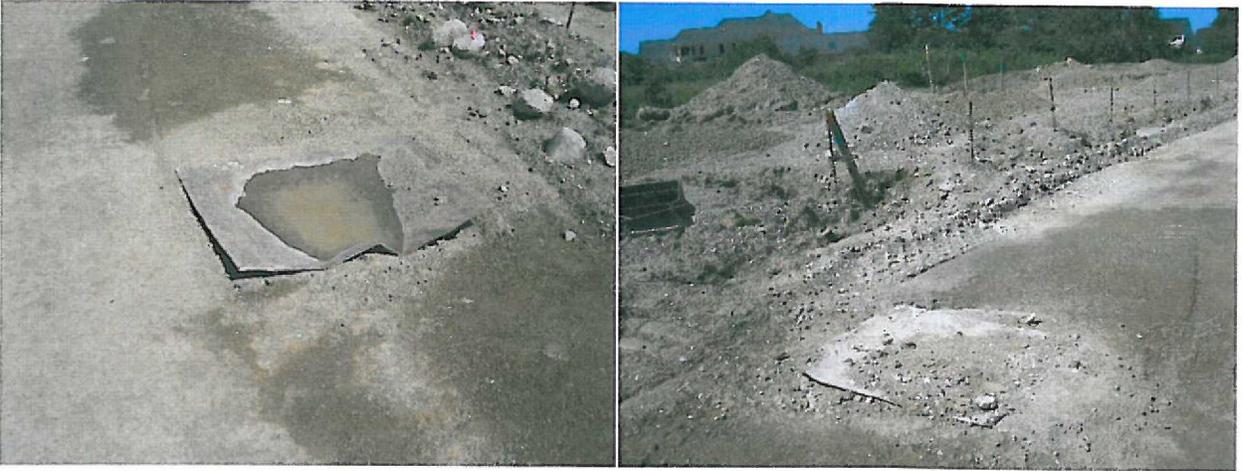
- **Storm drain inlet protection has not been constructed per specifications contained in the SWP3. (Figures 4&5)** Inlet protection was constructed simply by placing a metal plate over top the catch basins. This has resulted in failed storm drain inlet protection. Please note that geotextile is to be supported by a wooden frame and cross braces constructed of 2"x4"s as well as wire mesh. Please review the specifications contained in the SWP3 and in *Rainwater and Land Development, Ohio's Standards for Stormwater Management, Land Development and Urban Stream Protection* (Ohio Department of Natural Resources, 2006), and install/repair inlet protection to meet these standards.

**Figures 4&5:** Metal plate does not provide proper inlet protection.

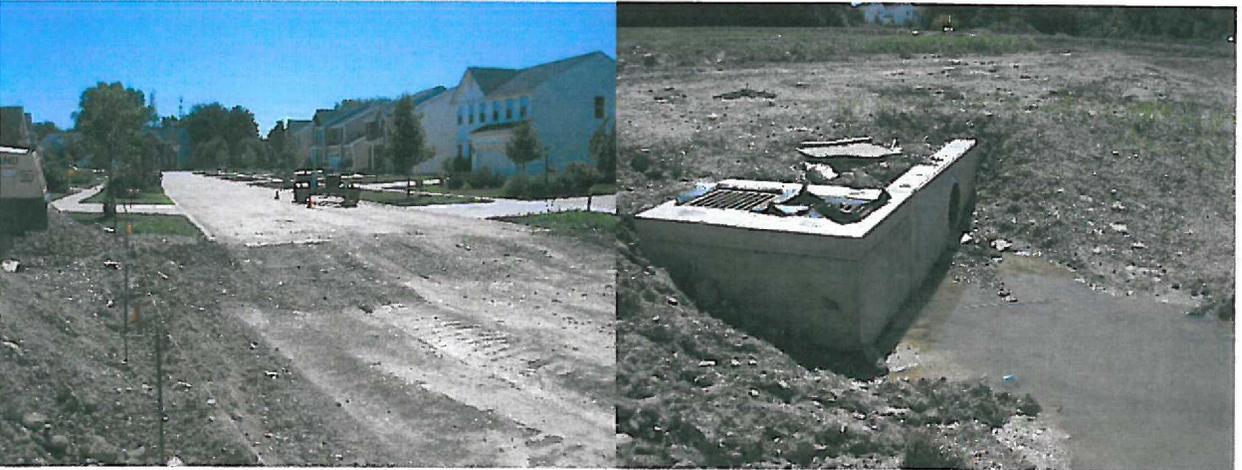
- **The Rock Construction Entrance was inadequate, resulting in sediment tracking off of the site. (Figure 6)** Specifications for a Rock Construction Entrance can be found in Chapter 7 of the *Rainwater and Land Development Manual, Ohio's Standards for Stormwater Management, Land Development and Urban Stream Protection* (Ohio Department of Natural Resources, 2006).

- **The NPDES permit states that if feasible; sediment settling ponds shall be dewatered at the pond surface using a skimmer or equivalent device. (Figure 7)**  
The sediment pond on site did not have a skimmer installed at the time of our inspection. In addition the NPDES permit states that sediment basins and perimeter sediment barriers shall be implemented prior to grading and within seven days from the start of grubbing. They shall continue to function until the up slope development area is restabilized. At the time of inspection, the sediment basin was incomplete.

**Figure 6:** Rock construction entrance is inadequate. **Figure 7:** Outlet structure is incomplete.

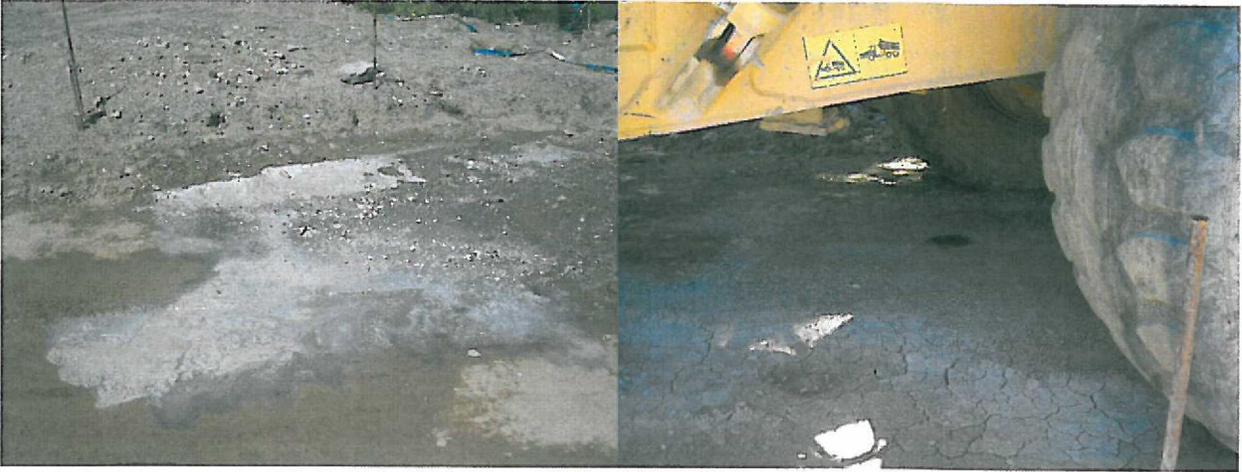
- **Non-sediment pollution controls require repair and maintenance as per the NPDES Permit. (Figures 8&9)** On site, we observed where concrete had been washed out on bare soil. **ALL concrete washout is to occur ONLY at a washout pit location.** In addition, a machine onsite was observed leaking fluid. Please note that machine leakage must be scooped up and disposed of in a covered dumpster or other trash receptacle.

**Figure 8** (left): Concrete is to be washed out in a washout pit.

**Figure 9** (right): Machine leakage must be properly disposed of in a covered dumpster.
