**RE: Speedway Store #005215; NPDES Permit # 1GC04629\*AG; Compliance Inspection Findings and Notice of Violation**

Ohio EPA DSW Storm Water Section, Construction Site Visit Information Form

Site Name: Speedway Store #005215

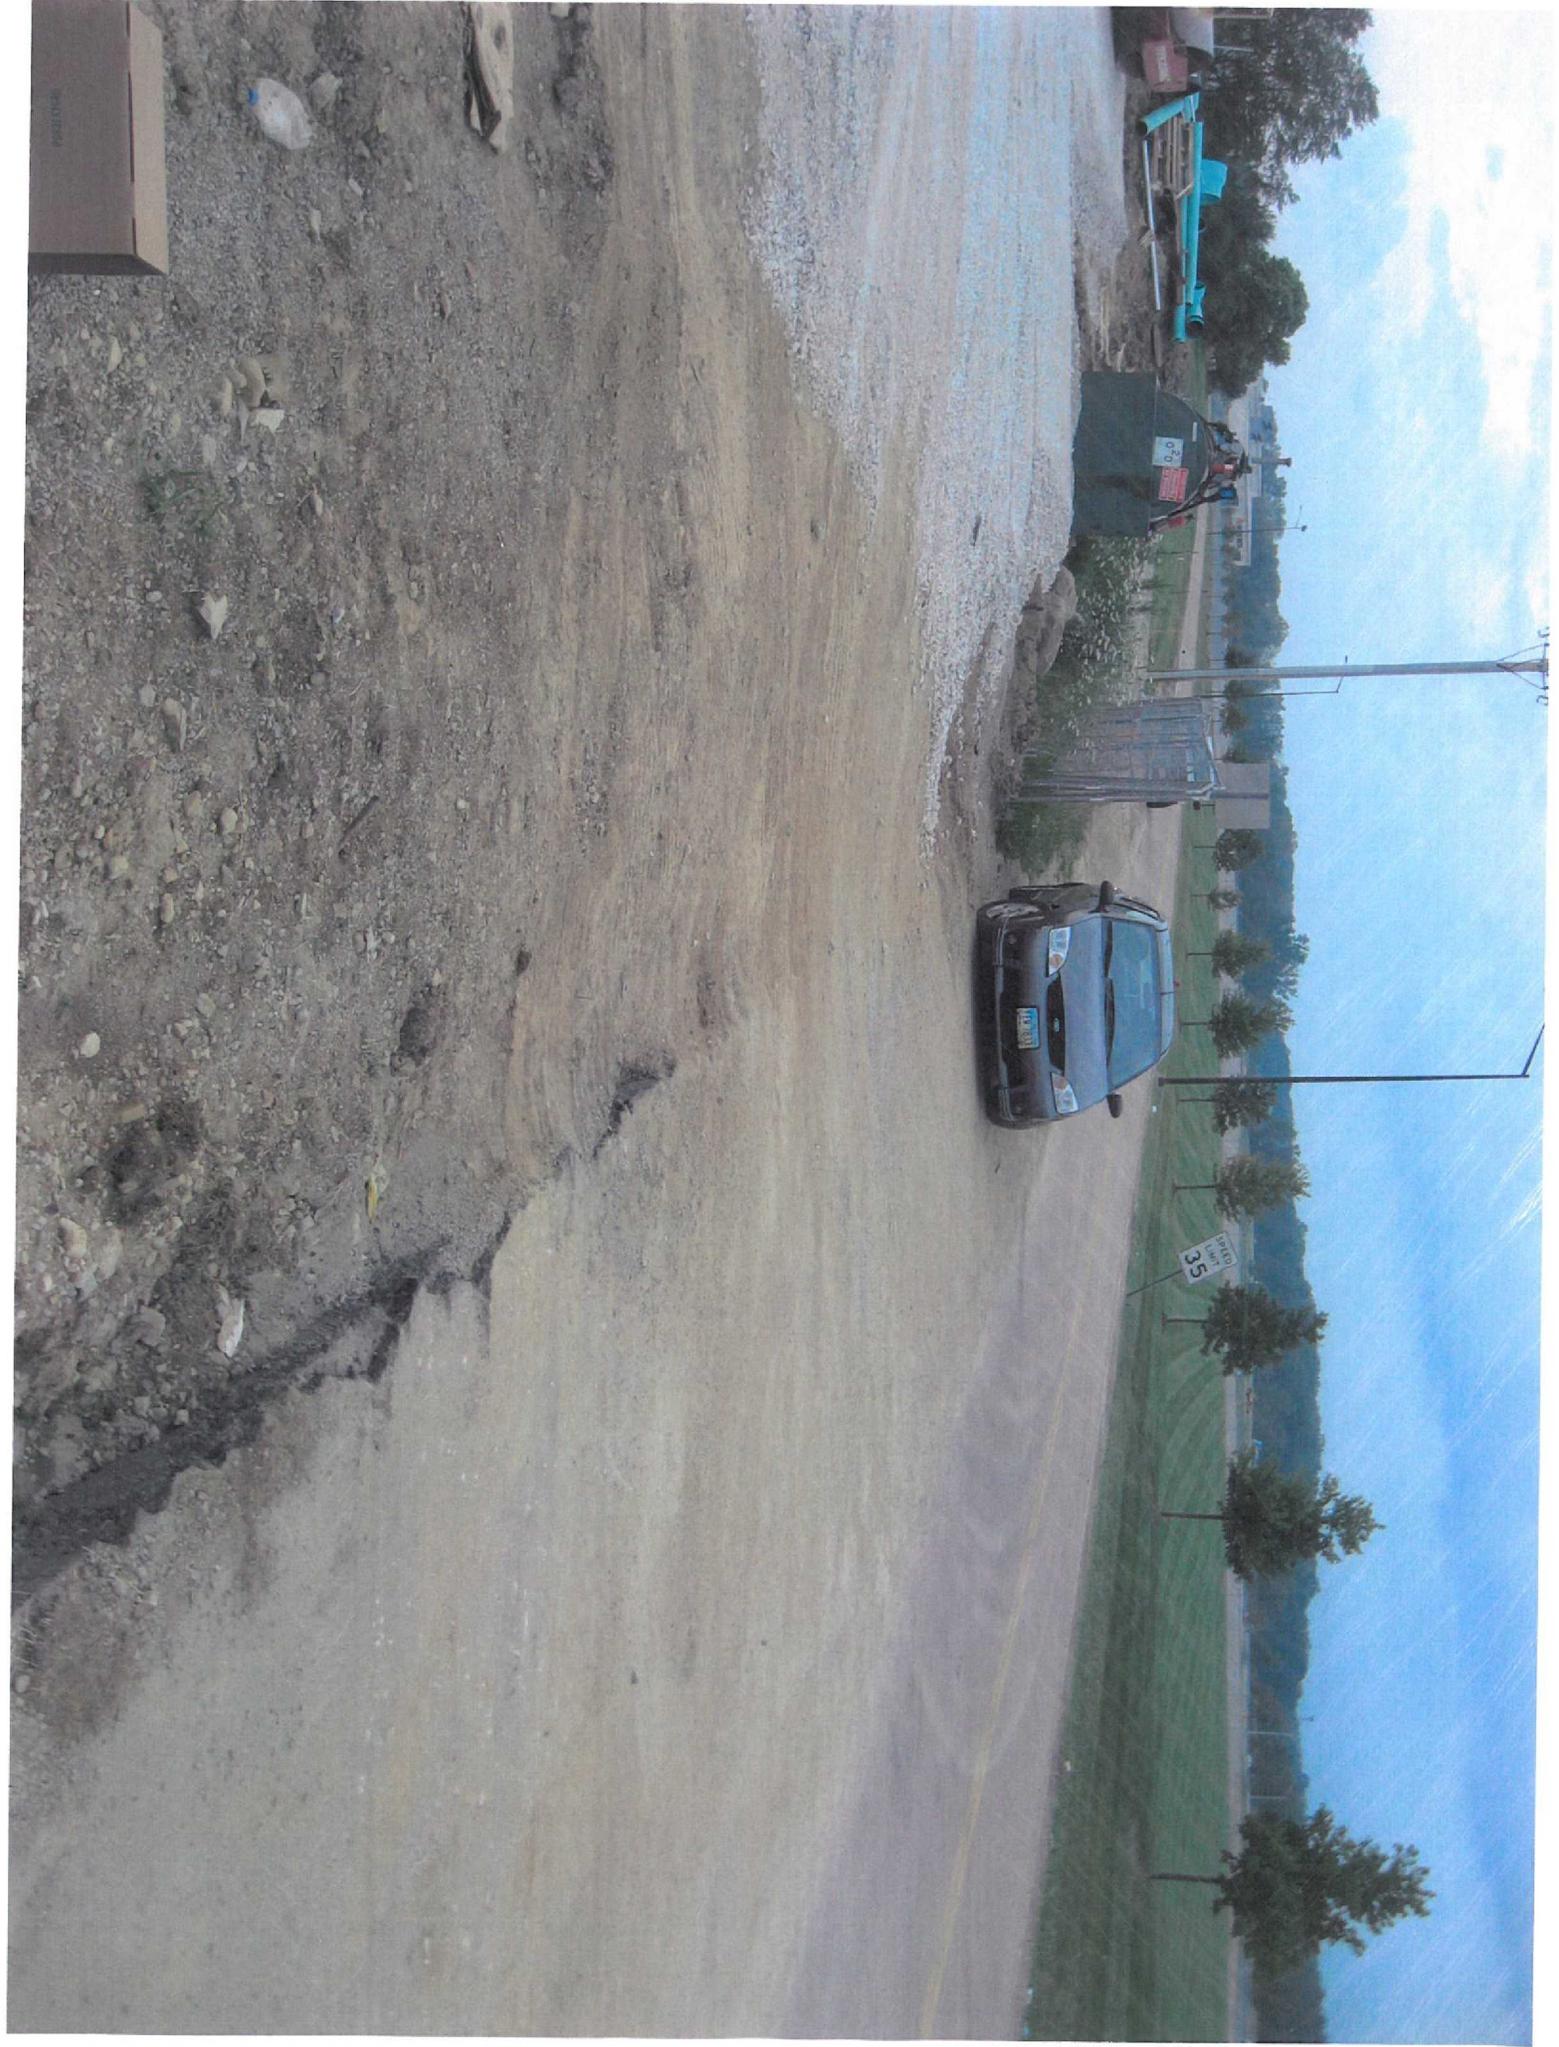
Failure to design, install and maintain effective erosion controls to minimize the discharge of sediment.

Specifically, this is referring to the construction entrance for the north side of the site. The photograph included with this letter documents the violation. The poorly built construction entrance is allowing a high volume of sediment to be dispersed onto Ritchie Drive. Rainfall will wash much of this sediment to storm drains that discharge in to Beaver Creek, in violation of the site's NPDES general construction permit. Construction entrances should be designed and installed based on the specifications described in Chapter 7.4 of the Ohio DNR's Rainwater and Land Development Manual. Here is the web link <http://www.dnr.state.oh.us/tabid/9186/default.aspx>.

Explain in your written response to this letter what measures will be taken to modify the construction entrance in order to minimize sediment from leaving the site. In addition, please provide a copy of the site's storm water pollution prevention plan to our office within 14 days of receipt of this letter.

Additional notes/comments:  
 - Fix Construction Entrance until paving of parking lot occurs.  
 - Stabilize barren soil on perimeter of site
