RE: MEDINA COUNTY
GRANGER TOWNSHIP
GRANGER UNITED METHODIST CHURCH
(PERMIT NO. 3PR00594)

On August 8, 2013, this writer conducted a compliance evaluation inspection (CEI) on the wastewater treatment plant (WWTP) serving the Granger United Methodist Church. The Granger United Methodist Church is located at 1235 Granger Road, Granger Township, Medina County.

The purpose of the inspection was to evaluate the WWTP's operation and maintenance condition, and its compliance with the terms and conditions of the recently effective NPDES Permit to discharge (Permit # 3PR00594*AD).

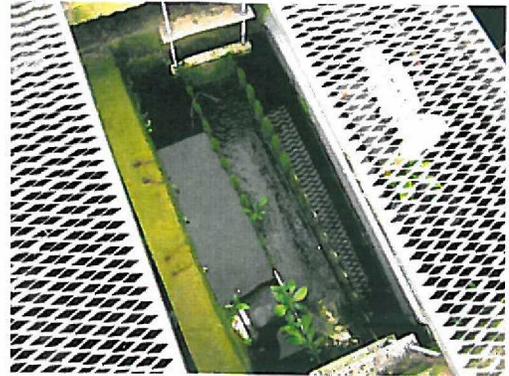
- 5) Contents of the settling tank were clear down to a depth of approximately 6", but did contain some floating scum and duckweed on the water surface. The settling tank effluent trough contained a deposition of solids; and there was a mossy

growth on the weirs of the trough and a few plants (see photo).

The effluent trough should be kept clean at all times, and the skimmer operational.

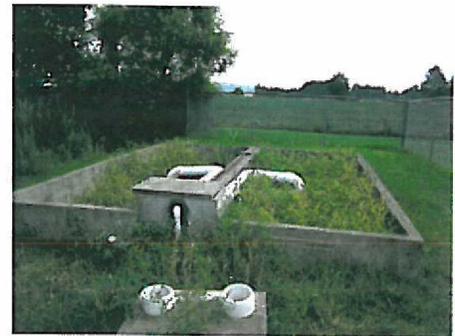
- 7) The north cell of the surface sand filter was dosed when the pumps were manually tested. Both the north and south filter cells contained a large amount of vegetative growth (see photo).

Vegetation in both of the filter cells needs to be removed, and the sand in both filter cells needs to be raked and kept level.
