September 23, 2013

**RE: Construction Storm Water Inspection at Jeff Wyler Chevrolet / Franklin County  
Permit Number: 4GC04115 \*AG**

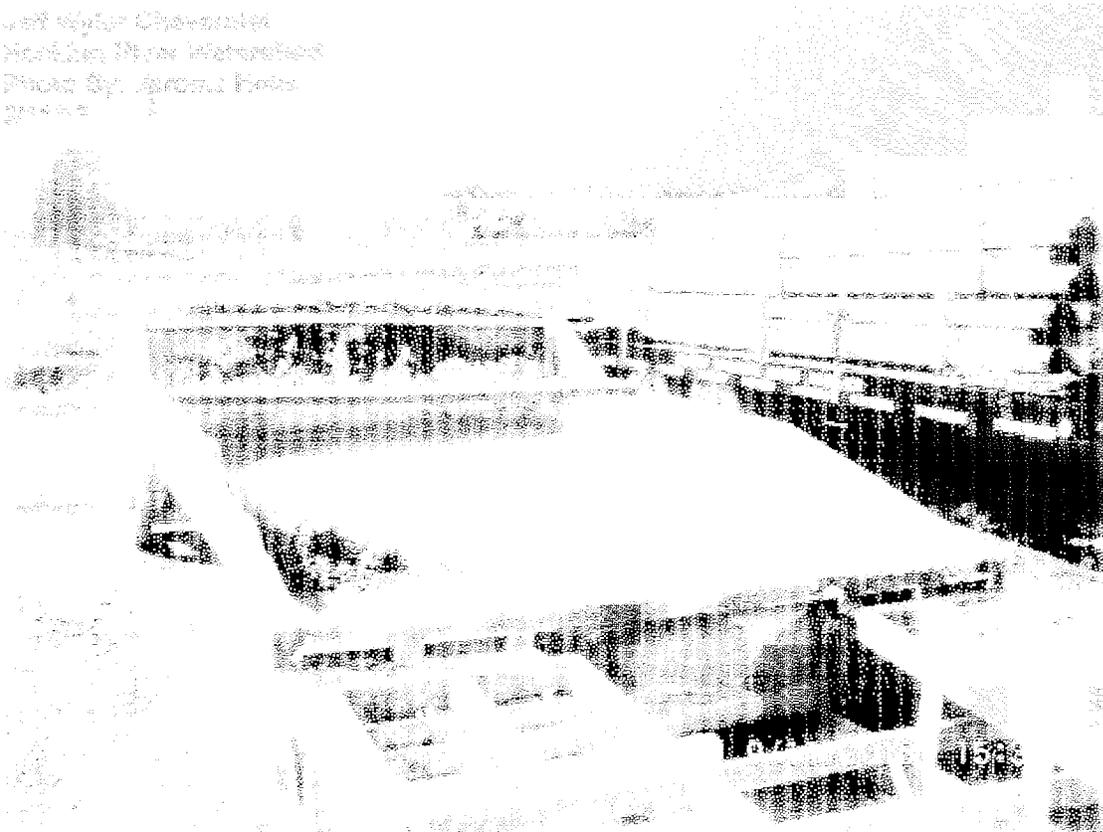
Figure 2: Concrete wa...hout requires maintenance

- The centralized sediment basin is currently modified for Post Construction (See Figure 1). A temporary riser and/or skimmer is required within ten (10) days from receipt of this letter to properly modify the basin for sediment control and ensure compliance with the General Permit.
- The concrete washout containment area appears to be close to overflowing. Maintenance is expected within three (3) days from receipt of this letter.
