**RE: Construction Storm Water Inspection at Southside Health Center/ Franklin County,
Permit Number: 4GC03866*AG**

This letter is written regarding a storm water inspection conducted by Jerome Hoke and Elizabeth Pleta of the Ohio EPA at Southside Health Center located at 1905 Parsons Road on September 23, 2013. The purpose of the inspection was to evaluate compliance with the General Storm Water Permit associated with Construction Activities. During the inspection, our staff noted the following issues associated with construction activities at this site:

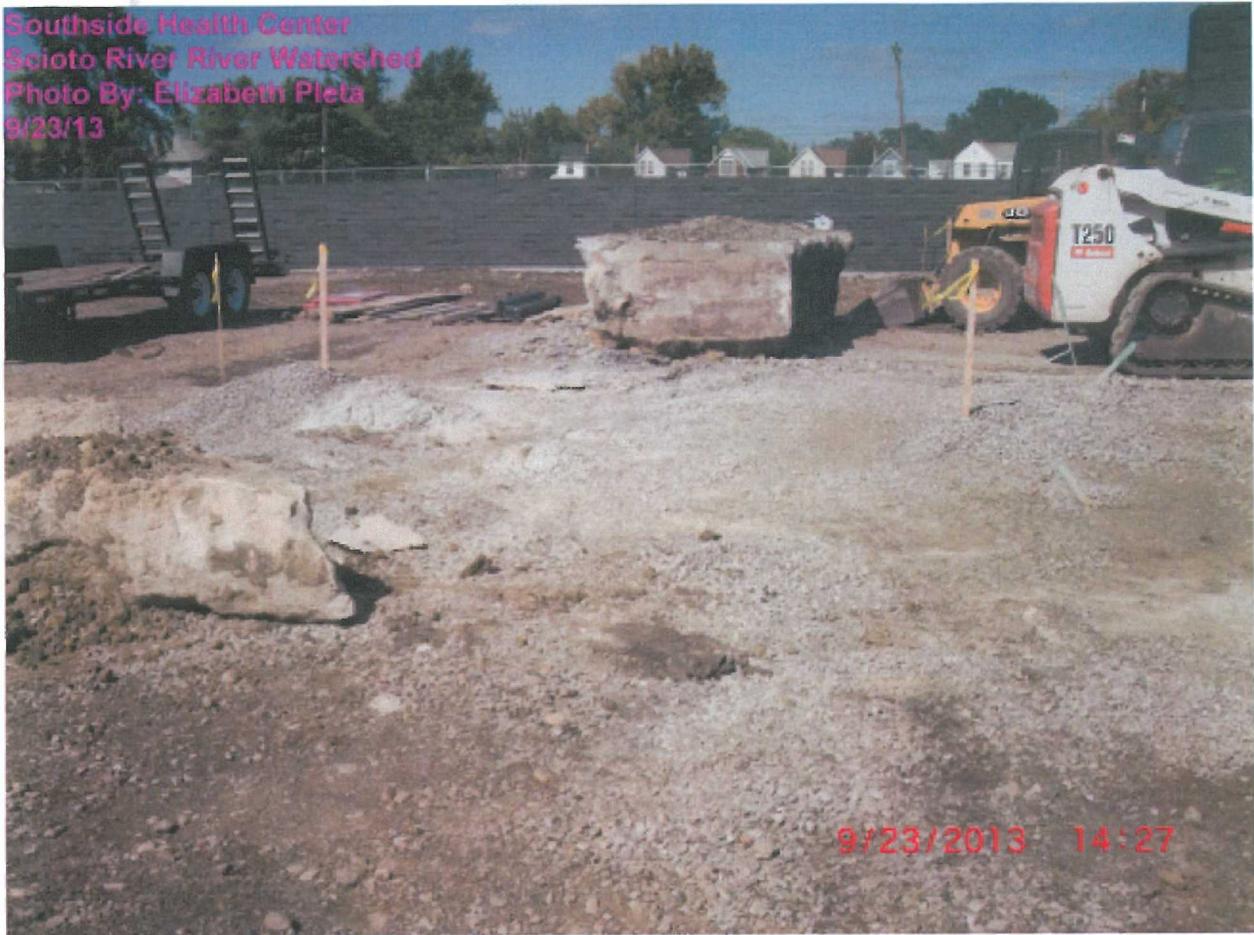
- Our staff observed an area of concrete disposal that lacked proper containment (See Figure 1). If future onsite disposal is required, containment measures such as a pit impoundment are expected.
- Please be aware measures are expected to ensure all barren areas are properly protected in preparation for the upcoming winter months. In the event earth disturbing activities extend beyond an effective growing season, alternate erosion protection is expected. This would include but not limited to a crimped straw mulch cover. Please submit to my attention the temporary seeding/protection schedule to ensure the erosion protection requirements are not violated.

Figure 1: Concrete washout activities require proper containment.
